# Manhole Inspection Summary

Manhole # S51C2\_016MH

Insp Date: **5/19/08 9:25 AM**

**Location** Address: **3502 8th Ave.**

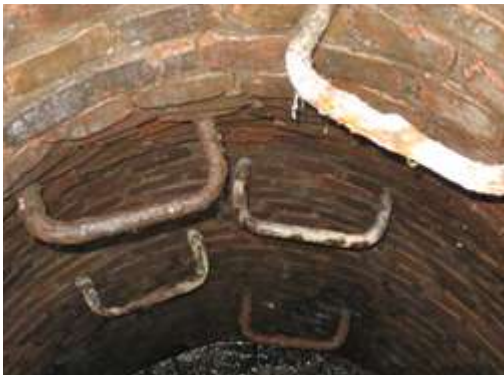
Steps

Count: **5** Missing: **0** ☒ **Corroded**

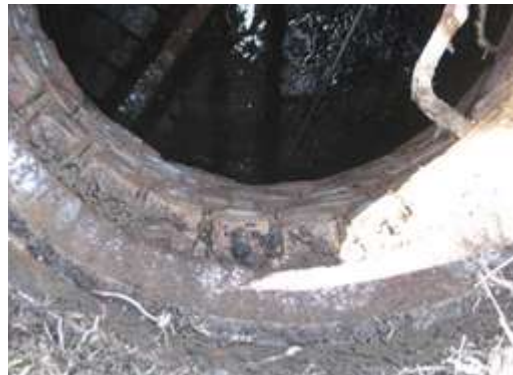
Defect 2

Offset: **1.5** (in.)

Frame-Chimney offset

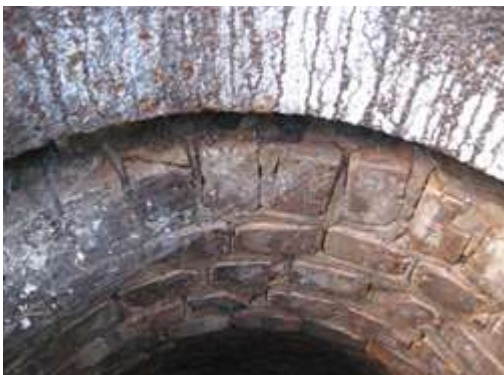
Defect 1

Condition: ☐ Sound ☒ **Cracked** ☐ Root Intrusion ☐ Loose Brick ☐ Deteriorated

Infiltration: ☐ None ☒ **Joint** ☒ **Cracks** ☐ Mortar ☐ Roots ☐ Wall

Cracked Frame-Chimney Joint

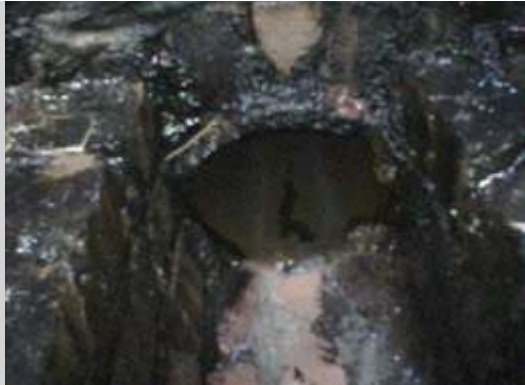
12 O'Clock Outflow

8 in. Circular Gravity Sewer  
Pipe Out @ 12 O'Clock

Pipe Height: **8.4** (in.) Rod and Bar (Angled)  
Pipe Material: **Clay** ☐ Pipe Lined  
Invert Depth: **9.65** (ft.) Flow Characteristics: **Fast**  
Deposits: ☒ None ☐ Mud ☐ Sludge ☐ Debris ☐ Grease  
Silt Depth: (in.) Deposits Extent:  
Infiltration: **Evidence** Pipe Seal Cond: **Unknown**

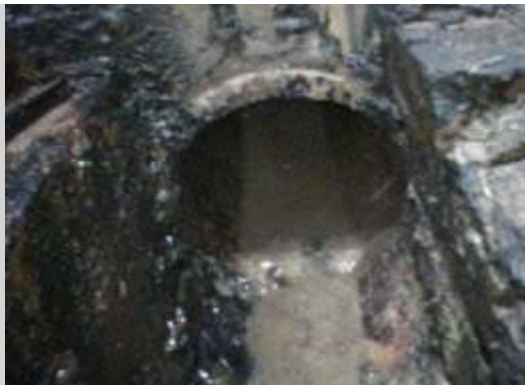
6 O'Clock Inflow

8 in. Circular Service Sewer  
Pipe In @ 6 O'Clock

Pipe Height: **8.4** (in.) Rod and Bar (Angled)  
Pipe Material: **Clay** ☐ Pipe Lined  
Invert Depth: **9.54** (ft.) Flow Characteristics: **Fast**  
Deposits: ☒ None ☐ Mud ☐ Sludge ☐ Debris ☐ Grease  
Silt Depth: (in.) Deposits Extent:  
Infiltration: **None** Pipe Seal Cond: **Sound**

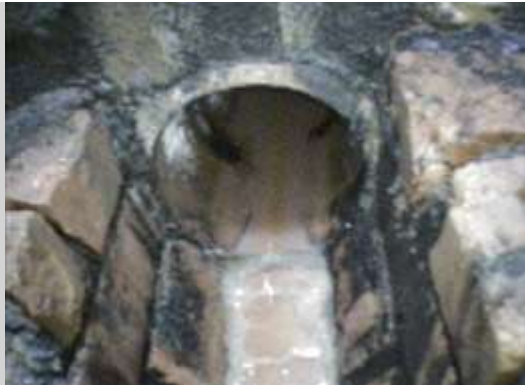
7 O'Clock Inflow

6 in. Circular Service Sewer  
Pipe In @ 7 O'Clock

Pipe Height: **7.2** (in.) Rod and Bar (Angled)

Infiltration: **None**

Pipe Seal Cond: **Sound**
